# CASE STUDY

## PROBLEM

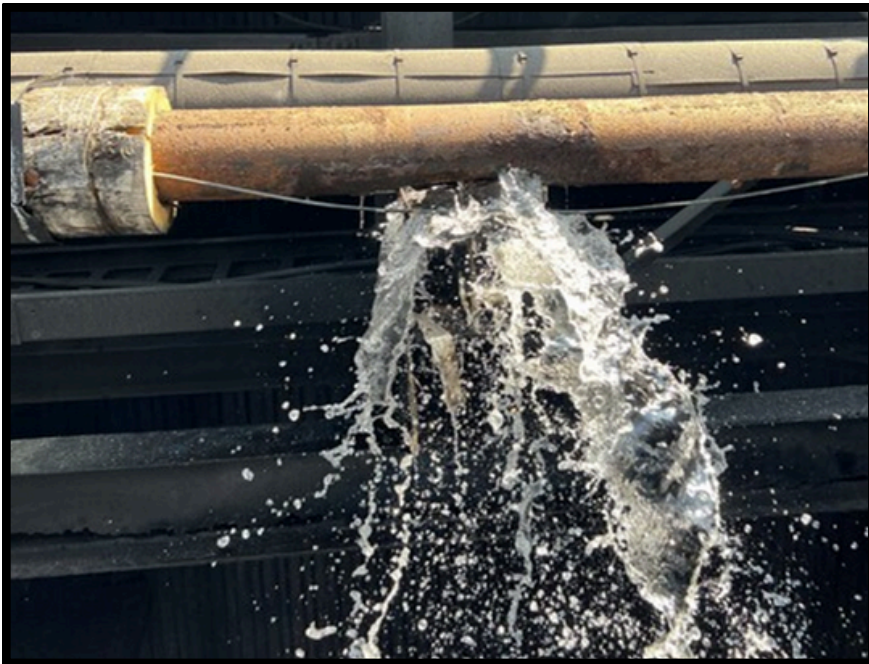
**BEFORE**

RAK received an urgent request from a customer to repair an active leak on an AC cooling line. The plant needed a swift and effective repair to minimize downtime and avoid compromising the AC system.

The job was completed by utilizing composite materials and injections to the area with an active leak. The job was successful, restoring the AC line to full functionality and ensuring the system's continued operation.
