# CASE STUDY

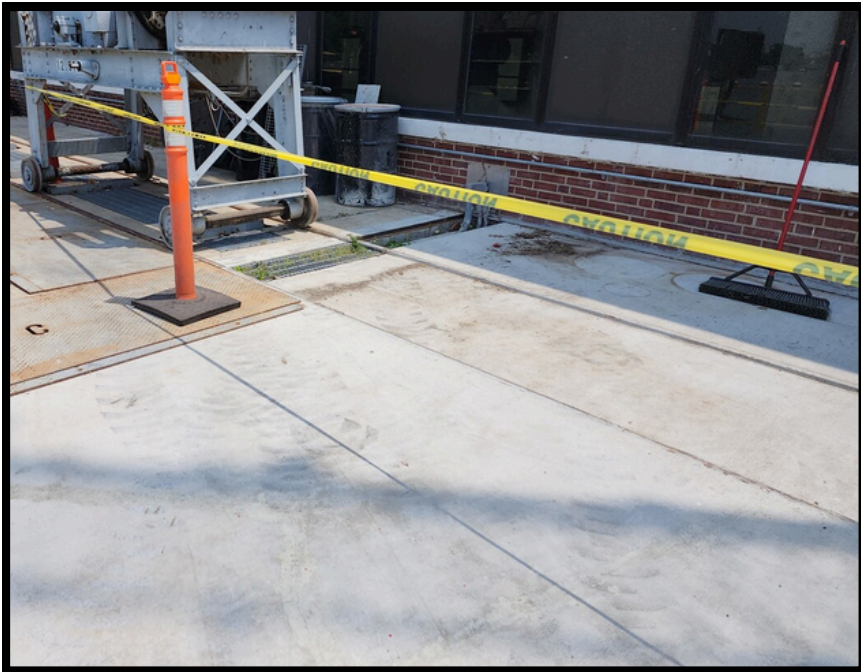
**BEFORE**

RAK was tasked with addressing issues related to concrete surface deterioration and joint sealing for a client whose structure was compromised. During RAK's assessment, significant water leakage through the joints was also identified.

To address the client's challenges, RAK implemented a multi-phase repair and sealing process. Our team prepared the concrete surface and applied multiple protective layers to enhance structural robustness and ensure long-term durability. This comprehensive approach resolved the issues of water ingress and joint failure, resulting in a successful and lasting repair.
