# CASE STUDY

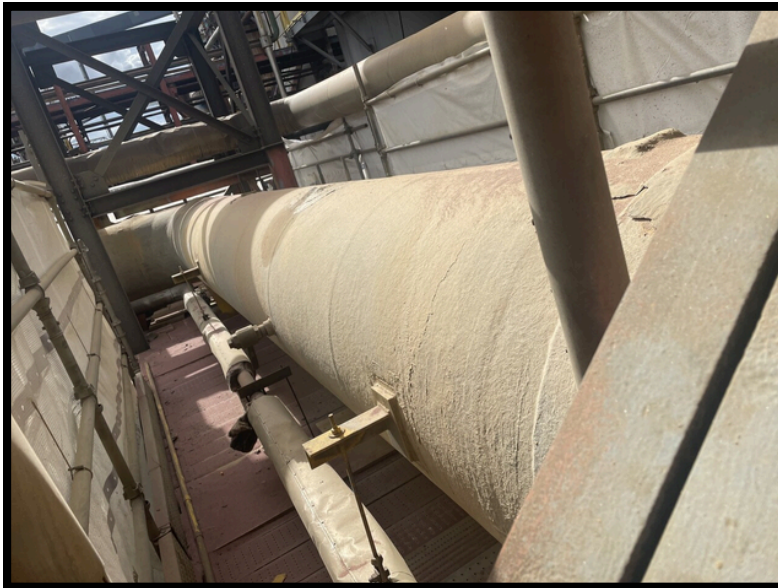
**BEFORE**

RAK received a call from a customer regarding multiple gas leaks that posed safety risks and needed to be addressed immediately to avoid downtime. The pipe had old, deteriorating brackets that required removal, and previously made fiberglass repairs had failed compromising the structural integrity of the pipe.

RAK designed and implemented a multi-step carbon fiber repair system to restore the structural integrity of the pipe and all work was performed with zero downtime.
