# CASE STUDY

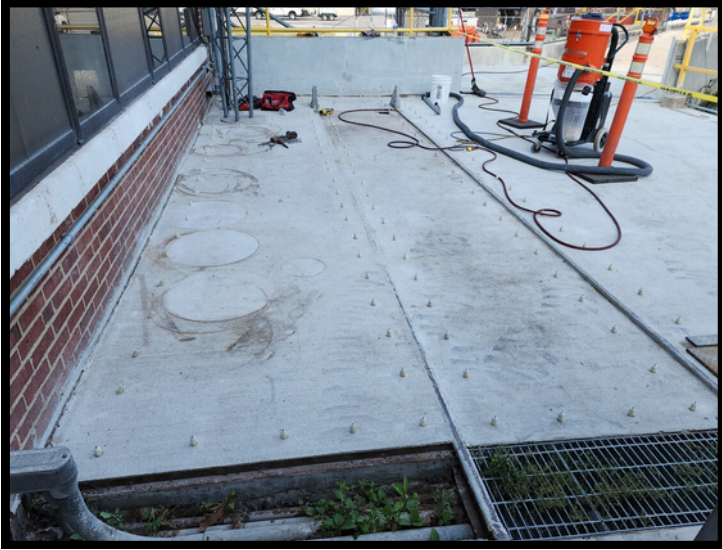
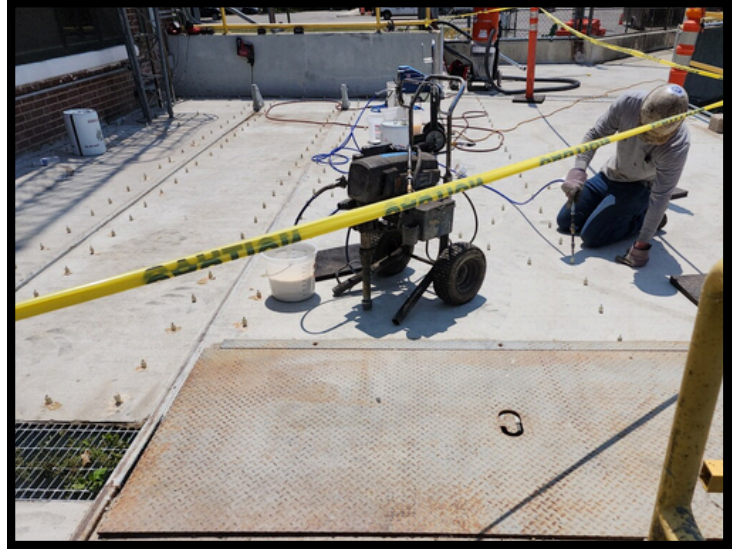
RAK was tasked with addressing issues related to concrete surface deterioration and joint sealing for a client whose structure was compromised. During RAK's assessment, significant water leakage through the joints was also identified.

- Significant water ingress through the joints was identified requiring a thorough and strategic repair approach.
- The concrete surface was meticulously prepared to ensure optimal adhesion for the next layers.
- RAK utilized an epoxy clear coat to provide durable protection for the customer.

To address the client's challenges, RAK implemented a multi-phase repair and sealing process. Our team prepared the concrete surface and applied multiple protective layers to enhance structural robustness and ensure long-term durability. This comprehensive approach resolved the issues of water ingress and joint failure, resulting in a successful and lasting repair.
