# CASE STUDY

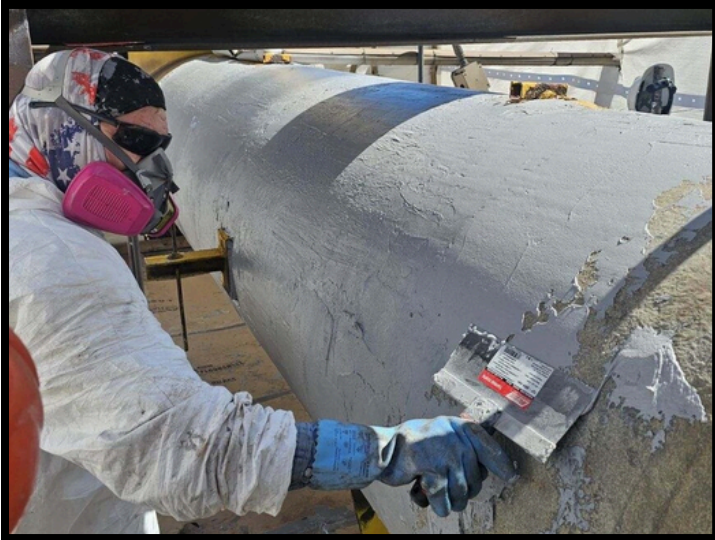
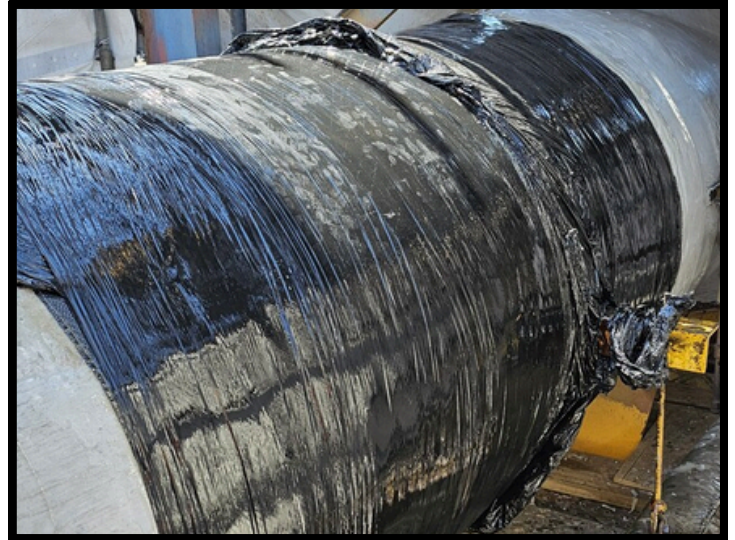
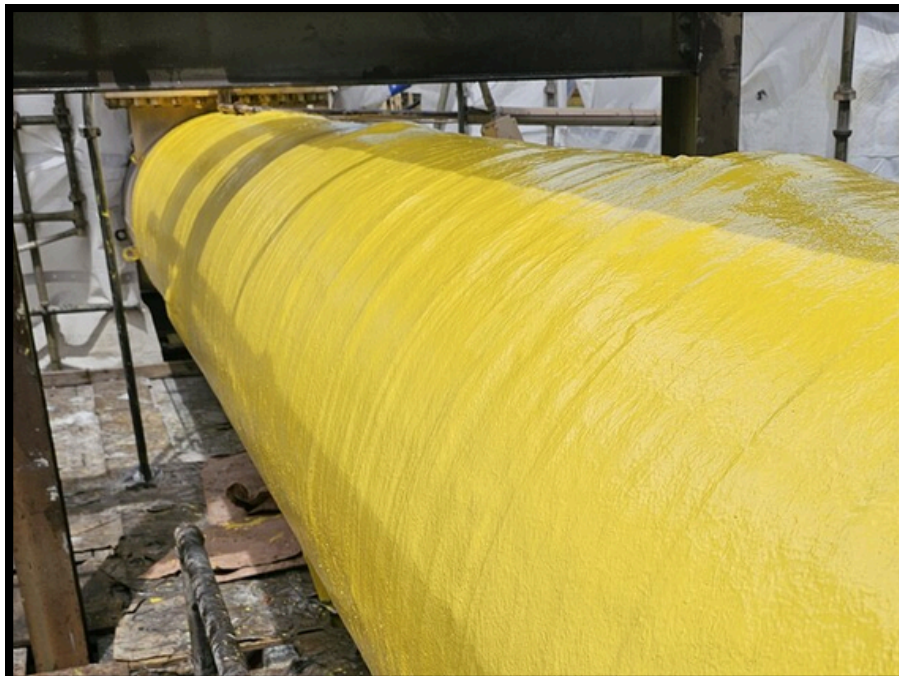
# PROJECT PICTURES

RAK received a call from a customer regarding multiple gas leaks that posed safety risks and needed to be addressed immediately to avoid downtime. The pipe had old, deteriorating brackets that required removal, and previously made fiberglass repairs had failed compromising the structural integrity of the pipe.

RAK designed and implemented a multi-step carbon fiber repair system to restore the structural integrity of the pipe and all work was performed with zero downtime.
